Cost-effective Dual-axis Inclinometer: BWM826-30-485

Cost-effective Dual-axis Inclinometer - Technical Indicators

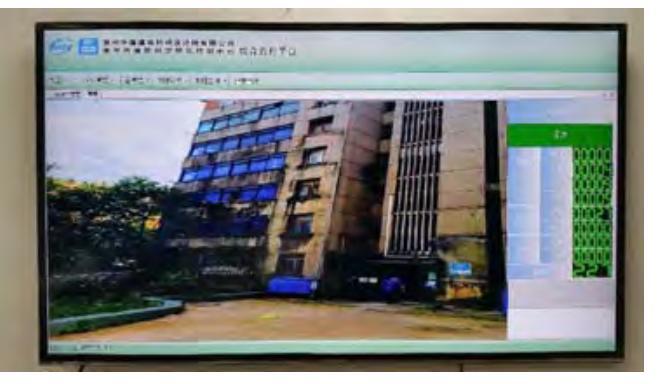
Guizhou Provincial Construction Science Testing Center Guizhou Provincial comprehensive information monitoring platform for dangerous old houses in

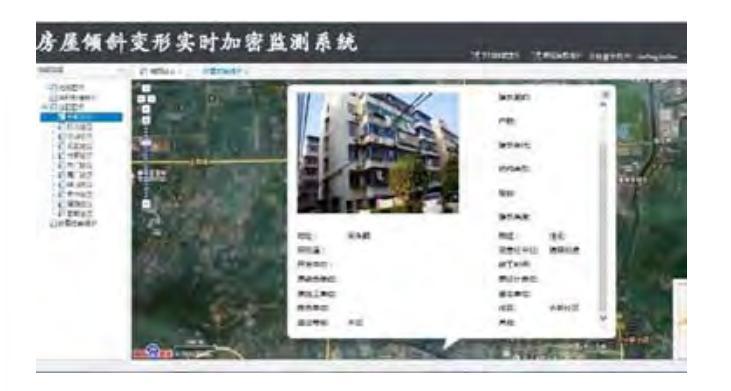
Beijing Zhufu International Engineering Technology Co., Ltd. House tilt deformation encryption dynamic monitoring system

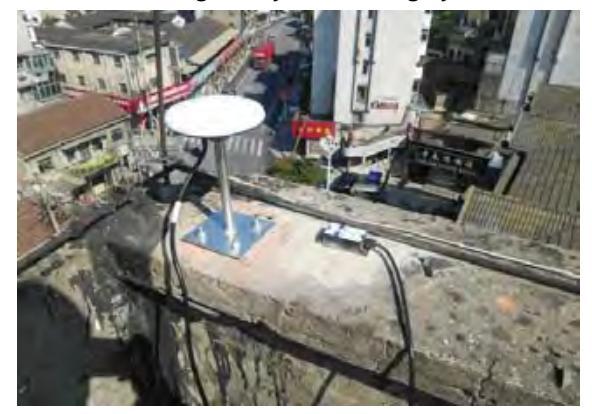
Hangzhou Zhuocheng Building Reinforcement Engineering Co., Ltd. Housing safety monitoring system

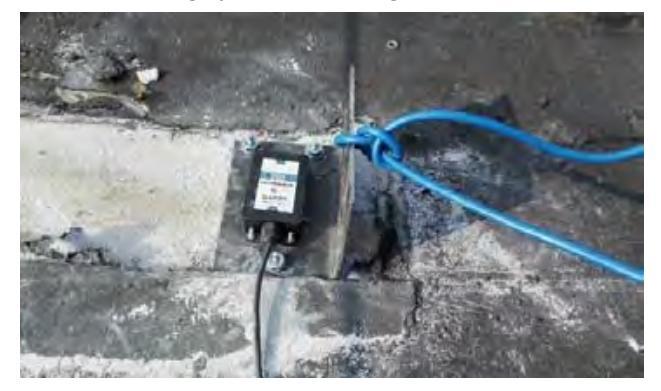
Zhejiang University Zhengcheng Technology Co., Ltd. Urban and rural housing safety monitoring system & management platform

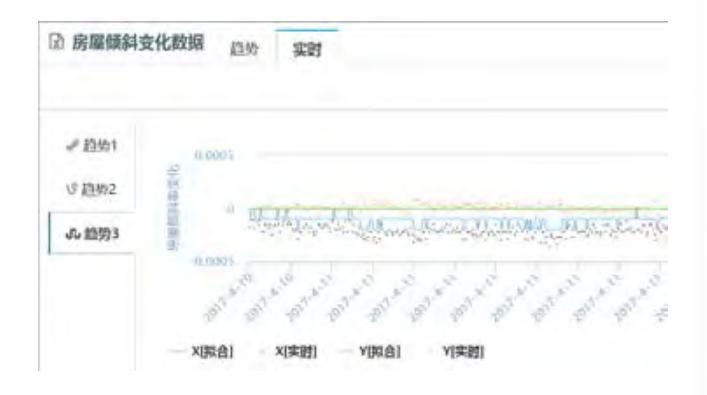
Hangzhou Haochi Technology Co., Ltd. Building safety monitoring IoT platform
